# Dams, Bridges and Culverts Assessment Technical Memorandum

## Wood-Pawcatuck Watershed Flood Resiliency Management Plan

Wood-Pawcatuck Watershed Association

October 2016

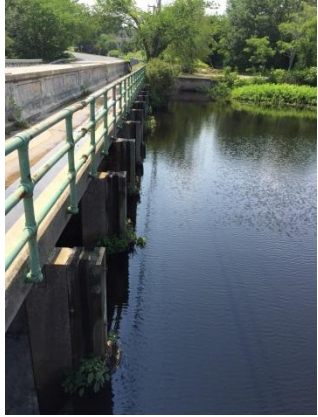
Ashaway Line Pond Dam	266	Hopkinton	Ashaway River	Remove	The impoundment is currently used for fire suppression, although the owner is not opposed to removal. The downstream watercourse is open to fish passage, and the dam is deteriorating. Removal should be considered.

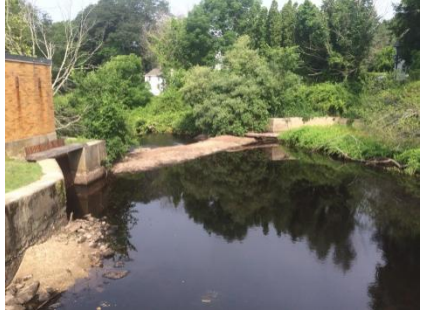
Ashaway Mill Pond Dam	265	Hopkinton	Ashaway River	Remove	This dam is part of the RIDOT bridge supporting High Street (Route 216). The impoundment does not appear to support any active uses. The dam is deteriorating. Removal is recommended in conjunction with Ashaway Line Pond Dam removal.

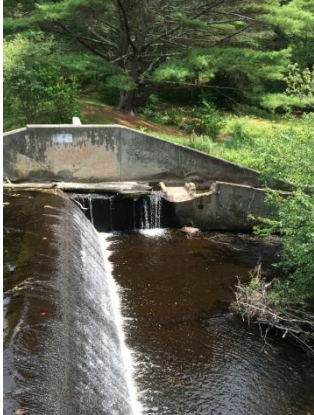
Browning Mill Pond Dam	221	Exeter	Roaring Brook	Repair	RIDEM owns the dam and operates a hatchery downstream. Browning Mill Pond has significant public recreational value. The dam is deteriorating.

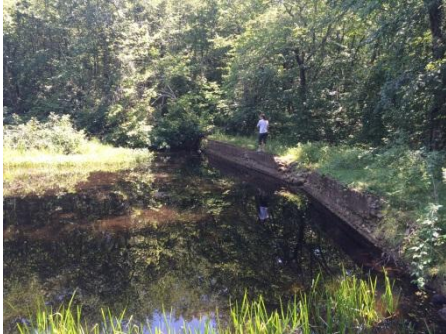
Potter Hill Dam	254	Hopkinton	Pawcatuck River	Remove	Although the dam has a fish ladder, removal of the dam should be considered to enhance AOP and flood resiliency. Concerns exist about impacts to upstream wetland habitats based on previous evaluations by the U.S. Fish and Wildlife Service.

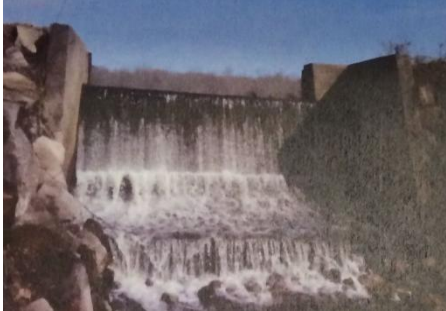
Wood River Junction Dam	273	Richmond	Meadow Brook	Remove	According to RIDEM Dam Safety, the dam is owned by RIDOT, but there is no official owner designation. Dam is in generally poor condition and is not being maintained although the impoundment has high recreational value. Removal should be considered.

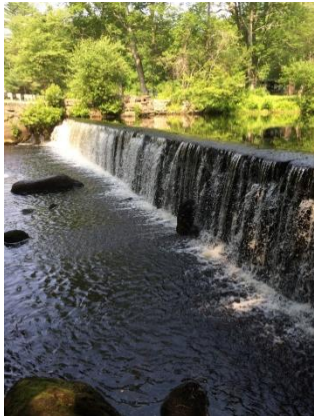
Blue Pond Dam	229	Hopkinton	Blue Pond Brook	Formalize Breach	The dam is partially breached, currently supporting a reduced impoundment. Further erosion and embankment failure could occur during high flows. Formalizing the partial breach is recommended. RIDEM has considered managing the impoundment as a waterfowl management area, which could also be reconsidered.

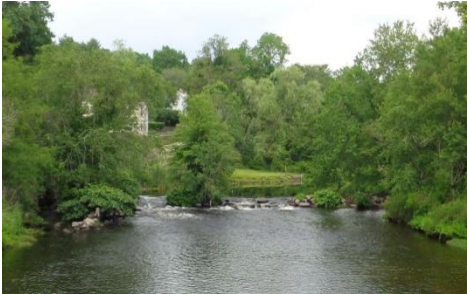
Centerville Pond Dam	223	Hopkinton	Moscow Brook	Remove (Re- evaluate hazard class)	The dam is deteriorating and not being maintained. The only current known use of the impoundment is private recreation. Removal should be considered. The hazard classification of the dam should be re-evaluated given the downstream infrastructure.

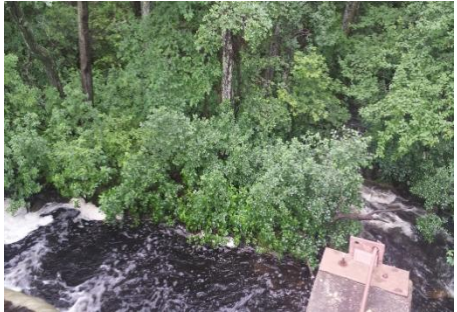
Edward's Pond Dam	238	Exeter	Queen River	Remove	The impoundment does not appear to support any active uses. A NOV was issued in 2015 for vegetation on the embankment. The dam is classified as a significant hazard. Removal should be considered.

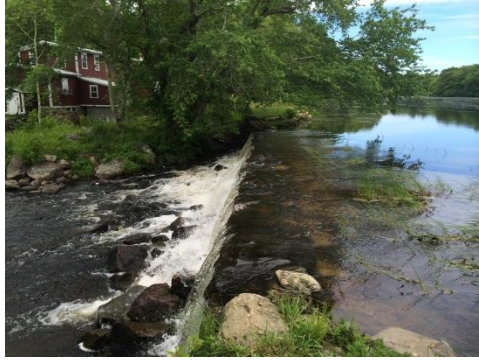
Hoxie Farm Pond Dam	440	Hopkinton	Canonchet Brook Tributary	Remove (Replace culvert to maintain roadway)	Replace culvert with larger structure and lower invert to drain impoundment and decommission dam. Repurposing was evaluated and determined not to be a priority based on location, lack of downstream hazards and hydrology.

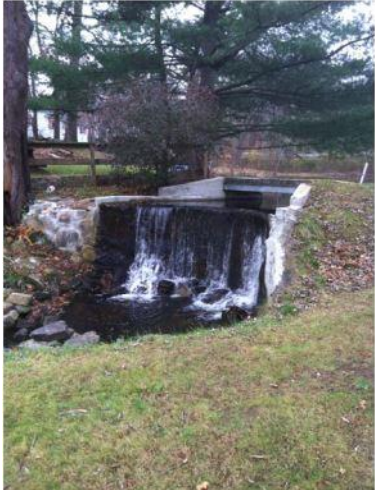
Locustville Pond Dam	262	Hopkinton	Brushy Brook	Maintain/ AOP Structure	The dam is a hydropower dam and powers the commercial buildings downstream of the dam. Owners recently repaired but did not apply to RIDEM for permits for repairs. Repairs have not been inspected by RIDEM and current status is unknown. The dam should be maintained. An AOP structure should be considered once the downstream obstructions are removed.

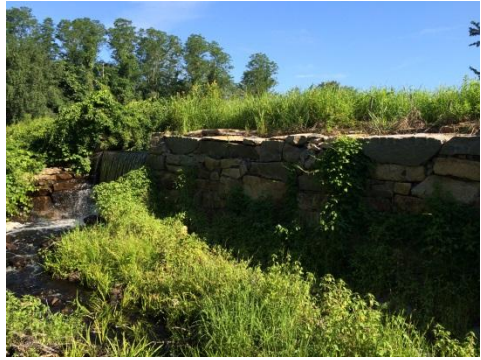
Union Pond Dam	288	Hopkinton	Blue Pond Brook	Remove	The impoundment supports private recreational uses. Owner lives out of state and does not actively maintain the dam. Secondary spillway was reportedly breached in 2010 when Blue Pond Dam breached, but has since been dammed by beavers. Dam removal should be considered.

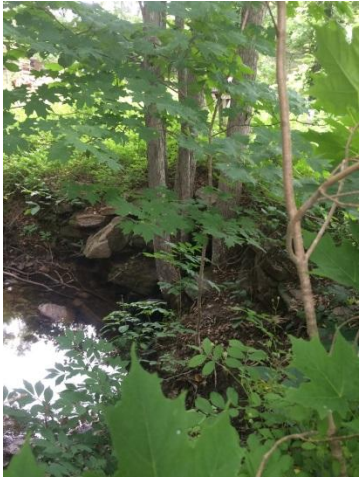
Hallville Pond Dam	571	Exeter	Sodom Brook	Remove	<p>The dam is in poor condition and is not being maintained. The impoundment does not appear to support any active uses. Removal should be considered.</p>

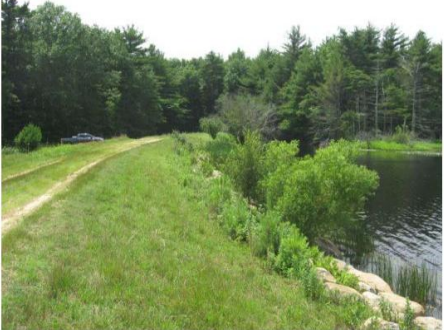
Olaf Farm Pond Dam	493	Westerly	Cedar Swamp Brook	Repair	The owner is currently maintaining this low hazard dam, but further repairs are needed (dense vegetation on slopes and erosion at informal secondary spillway). The owner is currently opposed to removal.

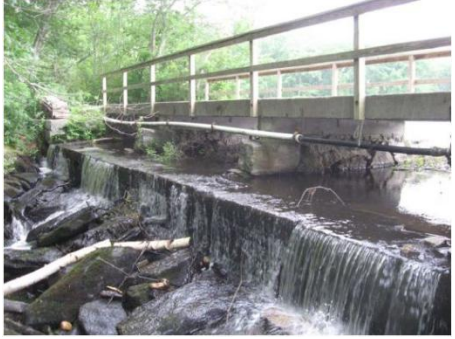
Slocum Road Lower Dam	711	Exeter	Chipuxet River Tributary	Remove	Dam is in disrepair and the impoundment provides private recreational uses. The owner lives out of state and does not actively maintain the dam. Removal should be considered.

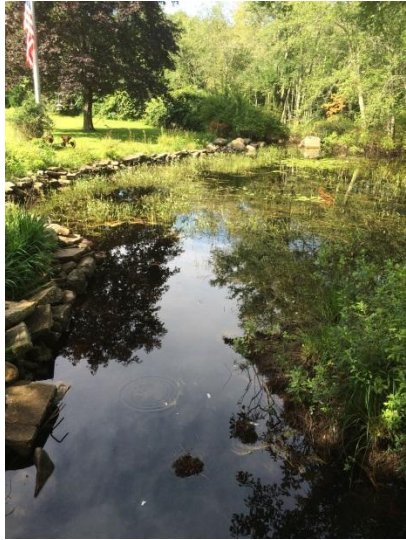
Sodco Dam	767	Exeter	Chipuxet River Tributary	Repair	The dam is owned by Sodco, and the impoundment supports turf farming operations. The dam is in disrepair, but the owner has been working with NRCS on the design of repairs to the dam and to allow the dam to overtop.

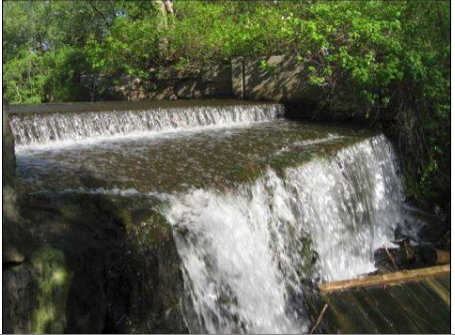
Wyoming Pond Lower Dam	217	Hopkinton	Wood River	No Action	The remaining structure is not preventing fish passage, is not significantly impacting the flow regime, and is only on one of several braided stream channels. The dam does not pose significant flood risk.
