# Dams, Bridges and Culverts Assessment Technical Memorandum

## Wood-Pawcatuck Watershed Flood Resiliency Management Plan

Wood-Pawcatuck Watershed Association

October 2016

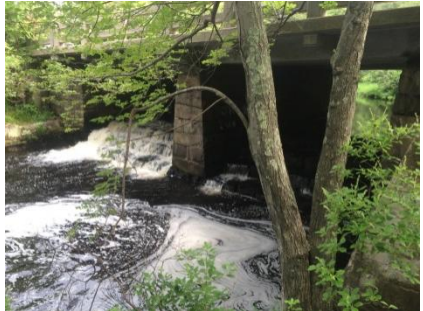
Ashaway Mill Pond Dam	265	Hopkinton	Ashaway River	Remove	This dam is part of the RIDOT bridge supporting High Street (Route 216). The impoundment does not appear to support any active uses. The dam is deteriorating. Removal is recommended in conjunction with Ashaway Line Pond Dam removal.

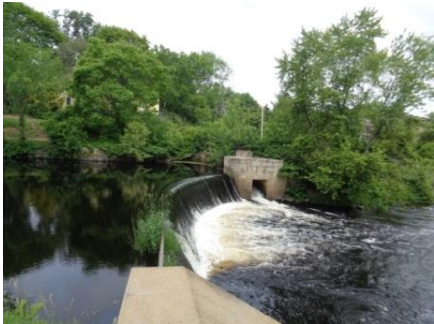
Potter Hill Dam	254	Hopkinton	Pawcatuck River	Remove	Although the dam has a fish ladder, removal of the dam should be considered to enhance AOP and flood resiliency. Concerns exist about impacts to upstream wetland habitats based on previous evaluations by the U.S. Fish and Wildlife Service.

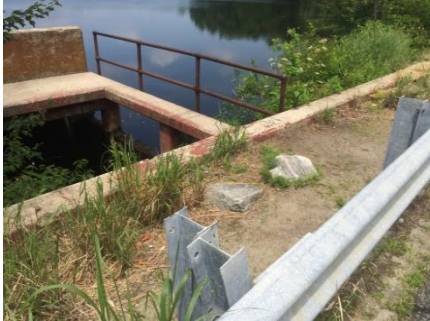
Wood River Junction Dam	273	Richmond	Meadow Brook	Remove	According to RIDEM Dam Safety, the dam is owned by RIDOT, but there is no official owner designation. Dam is in generally poor condition and is not being maintained although the impoundment has high recreational value. Removal should be considered.

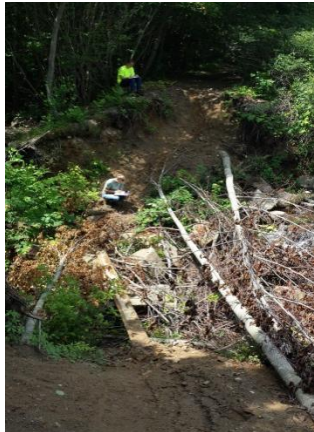
Blue Pond Dam	229	Hopkinton	Blue Pond Brook	Formalize Breach	The dam is partially breached, currently supporting a reduced impoundment. Further erosion and embankment failure could occur during high flows. Formalizing the partial breach is recommended. RIDEM has considered managing the impoundment as a waterfowl management area, which could also be reconsidered.

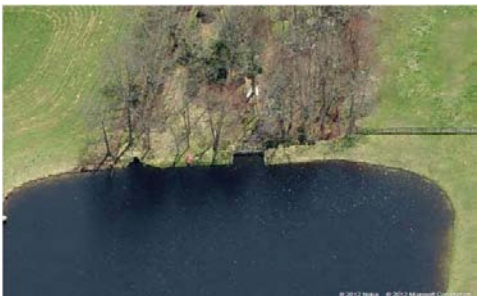
Edward's Pond Dam	238	Exeter	Queen River	Remove	The impoundment does not appear to support any active uses. A NOV was issued in 2015 for vegetation on the embankment. The dam is classified as a significant hazard. Removal should be considered.

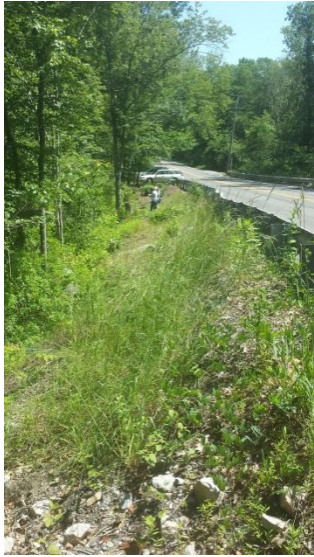
Hoxie Farm Pond Dam	440	Hopkinton	Canonchet Brook Tributary	Remove (Replace culvert to maintain roadway)	Replace culvert with larger structure and lower invert to drain impoundment and decommission dam. Repurposing was evaluated and determined not to be a priority based on location, lack of downstream hazards and hydrology.

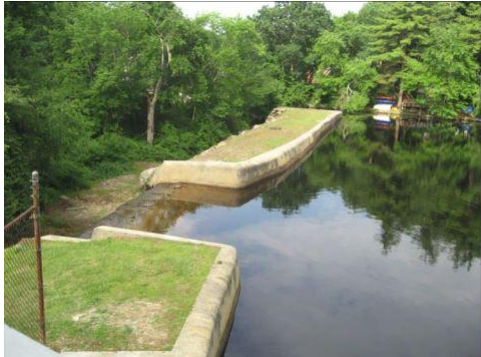
Locustville Pond Dam	262	Hopkinton	Brushy Brook	Maintain/ AOP Structure	The dam is a hydropower dam and powers the commercial buildings downstream of the dam. Owners recently repaired but did not apply to RIDEM for permits for repairs. Repairs have not been inspected by RIDEM and current status is unknown. The dam should be maintained. An AOP structure should be considered once the downstream obstructions are removed.

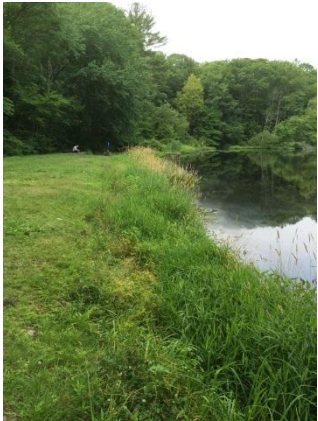
Dam Name	Dam ID	Town	River/Stream	Recommendation	Description	Photograph
Moscow Pond Dam	222	Hopkinton	Moscow Brook	Remove (Re-evaluate hazard class)	<p>Impoundment is used for fishing. Although the dam is deteriorating, a public road traverses the dam crest and there appears to be a house downstream of the dam. Removal should be considered, and the hazard classification should be re-evaluated.</p>	 
Porter Pond Dam	13602	Sterling	Wood River	Remove	<p>The impoundment supports limited recreation uses. The owner of the dam could not be identified. The dam is not being maintained and is in disrepair. Removal should be considered.</p>

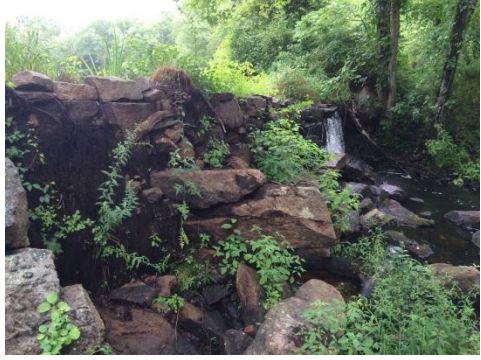
Union Pond Dam	288	Hopkinton	Blue Pond Brook	Remove	The impoundment supports private recreational uses. Owner lives out of state and does not actively maintain the dam. Secondary spillway was reportedly breached in 2010 when Blue Pond Dam breached, but has since been dammed by beavers. Dam removal should be considered.

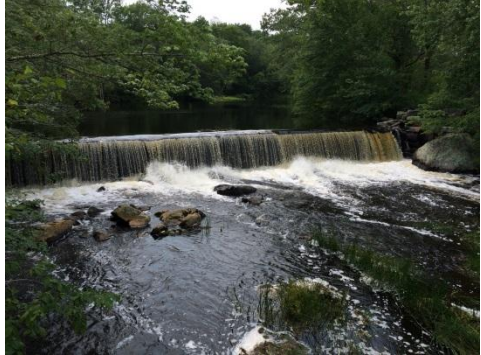
Dam Name	Dam ID	Town	River/Stream	Recommendation	Description	Photograph
Woodville Pond Dam	246	Hopkinton / Richmond	Wood River	Remove (Re-evaluate hazard class)	The impoundment supports no significant active uses and is in disrepair. Removal of the dam could promote connectivity and allow fish passage from the main stem of the Pawcatuck up Meadow Brook. Removal should be considered. Challenges to removal include owner support, use of the impoundment for fire suppression, impacts to upstream wetlands, scour on the downstream bridge, and potential impacts on adjacent dry wells.

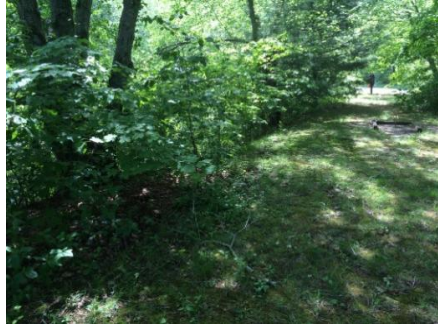
Dam Name	Dam ID	Town	River/Stream	Recommendation	Description	Photograph
Arcadia Mill Lower Dam (Browning Mill Bypass Pond Dam)	402	Hopkinton	Roaring Brook	Maintain	This impoundment is part of the RIDEM-owned Arcadia Warm Water Hatchery, which is still in partial operation and is also used for fire suppression.

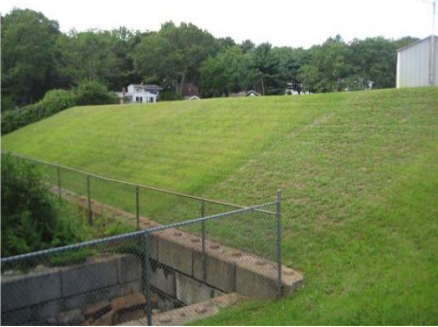
Boone Lake Dam	219	Exeter	Roaring Brook	Maintain	The owner's association is very active and maintains the dam. It is understood that the owners would not be supportive of removal.

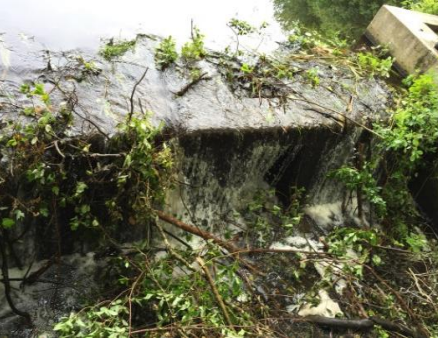
Dolly Pond Dam	243	Exeter	Sodom Brook	Remove	The dam is not being maintained and the owner is unknown. The impoundment supports private recreational uses. Removal should be considered, although it is understood that adjacent land owners may not be in favor of dam removal.

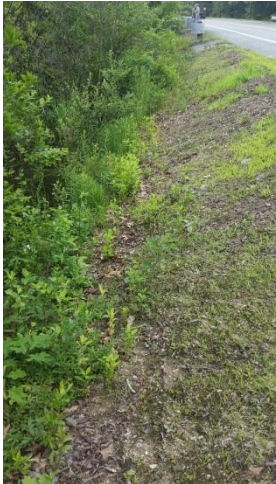
Dam Name	Dam ID	Town	River/Stream	Recommendation	Description	Photograph
Glen Rock Lower Pond Dam	233	South Kingstown	Glen Rock Brook	Remove	The impoundment does not support any known uses. The dam is not being maintained. Removal is recommended if supported by the owner.	No Recent Photographs Available
Glen Rock Middle Pond Dam	234	South Kingstown	Glen Rock Brook	Remove	The impoundment does not support any known uses. The dam is not being maintained. Removal is recommended if supported by the owner.	No Recent Photographs Available
Glen Rock Upper Pond Dam	235	South Kingstown	Glen Rock Brook	Remove	The impoundment does not support any known uses. The dam is not being maintained. Removal is recommended if supported by the owner.	No Recent Photographs Available
Grassy Pond Dam	289	Hopkinton	Wincheck Pond Tributary	Remove (Replace culvert to maintain roadway)	Dam was decommissioned by RIDEM (no longer on current dam list). The culvert could be replaced with a larger structure and lower invert to drain the impoundment. Repurposing was evaluated and determined not to be a priority based on location, lack of downstream hazards and hydrology.

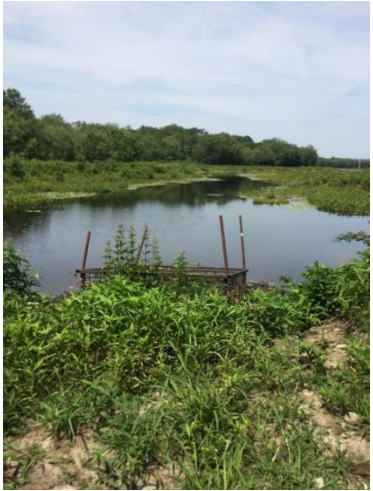
Dam Name	Dam ID	Town	River/Stream	Recommendation	Description	Photograph
Great Swamp Goose Marsh Dam	531	South Kingstown	Pawcatuck River	Repair	Dam was constructed by RIDEM to create bird habitat. Dam is a low hazard dam in disrepair.

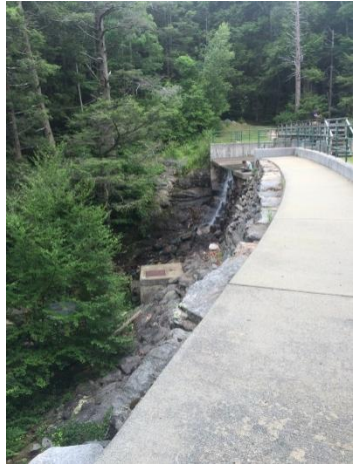
Green Falls Reservoir Dam	14701	Voluntown	Green Fall River	Maintain	Impoundment is located in the Pachaug State Forest and has significant public recreational value. Dam is in fair condition.

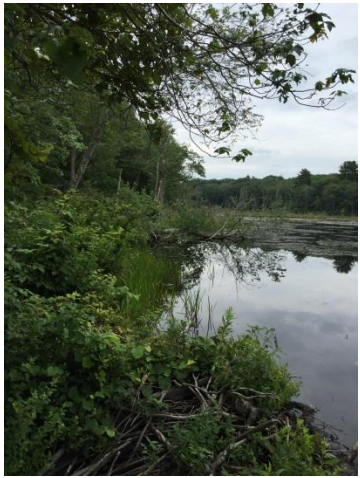
Hallville Pond Dam	571	Exeter	Sodom Brook	Remove	<p>The dam is in poor condition and is not being maintained. The impoundment does not appear to support any active uses. Removal should be considered.</p>

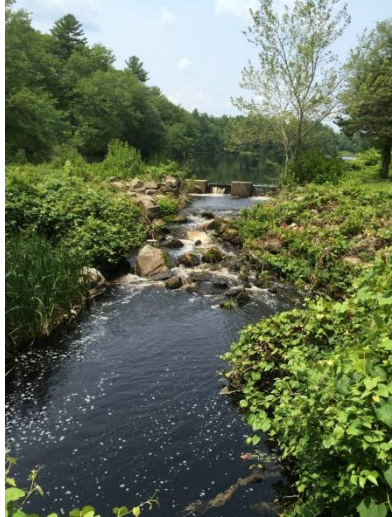
Dam Name	Dam ID	Town	River/Stream	Recommendation	Description	Photograph
Hazard Pond Dam	200	West Greenwich	Falls River	Remove	Dam is on the main stem of the Wood River. The downstream watercourse is unobstructed for 5+ miles until Barberville Pond, which is recommended for construction of a rock ramp or other fish passage structure. The impoundment does not appear to support any active uses.

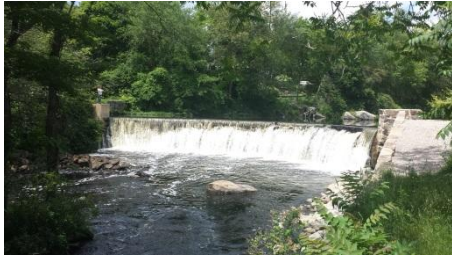
Hope Valley Mill Pond Dam	245	Hopkinton / Richmond	Wood River	AOP Structure	Dam is a historic structure and has been maintained as such. Fish were observed attempting to jump over the dam during the 2015 field assessment. Obstructions to fish passage exist downstream of the dam. Installation of an AOP structure is a low priority until the downstream obstructions are removed.

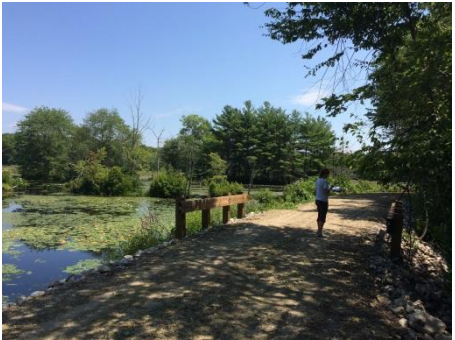
Dam Name	Dam ID	Town	River/Stream	Recommendation	Description	Photograph
Kasella Farm Pond Dam	468	West Greenwich	Breakheart Brook	Remove	The current uses of the dam are unknown. The dam was recently reconstructed when a road was built across the crest, but the dam requires further repair. Removal should be considered. Roadway could be maintained and culverts constructed to sufficiently drain the impoundment.

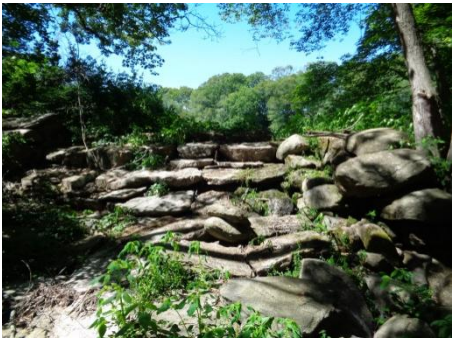
Lewis Pond Dam	10217	North Stonington	Pawcatuck River Tributary	Remove	While current uses are unknown, it appears that the owner may use the impoundment as a watering hole for cattle. Removal should be considered.

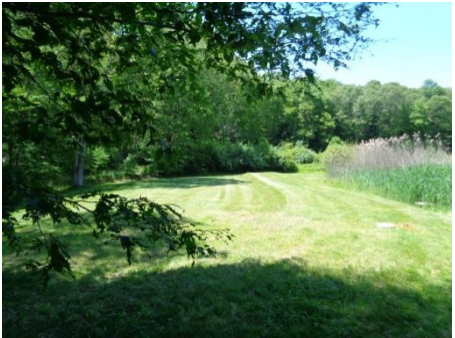
Liepold Pond Dam	13713	Stonington	Pawcatuck River	Maintain	The dam is being maintained, and the owner has indicated a desire to maintain the impoundment for private uses.

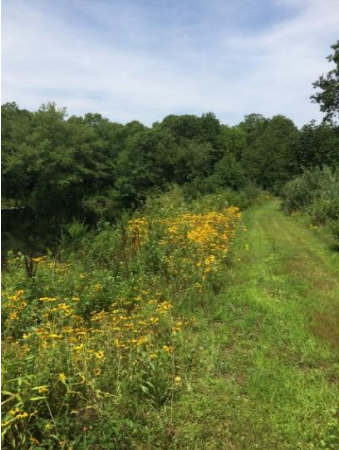
Olaf Farm Pond Dam	493	Westerly	Cedar Swamp Brook	Repair	The owner is currently maintaining this low hazard dam, but further repairs are needed (dense vegetation on slopes and erosion at informal secondary spillway). The owner is currently opposed to removal.

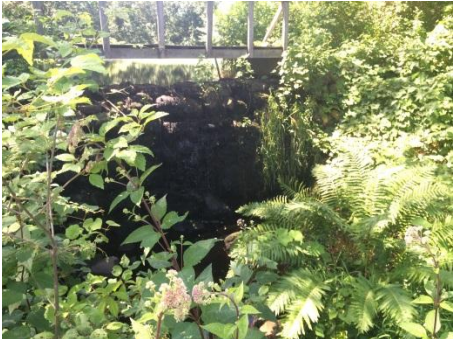
Slocum Road Lower Dam	711	Exeter	Chipuxet River Tributary	Remove	Dam is in disrepair and the impoundment provides private recreational uses. The owner lives out of state and does not actively maintain the dam. Removal should be considered.

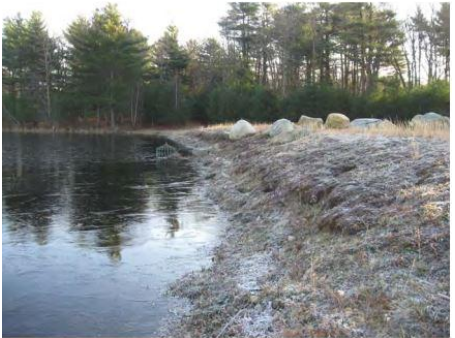
Slocum Woods Dam	693	North Kingstown	Chipuxet River Tributary	Maintain	Dam was in good condition in 2013 (last documented inspection) and is being maintained. It is owned by the Slocum Woods Homeowner's Association and is used for recreational purposes. The impoundment also appears to be used for irrigation for turf farming operations (Sodco).

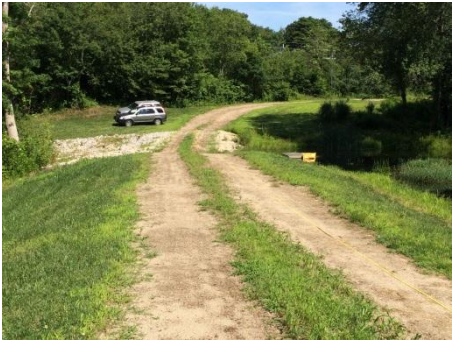
Sodco Dam	767	Exeter	Chipuxet River Tributary	Repair	The dam is owned by Sodco, and the impoundment supports turf farming operations. The dam is in disrepair, but the owner has been working with NRCS on the design of repairs to the dam and to allow the dam to overtop.

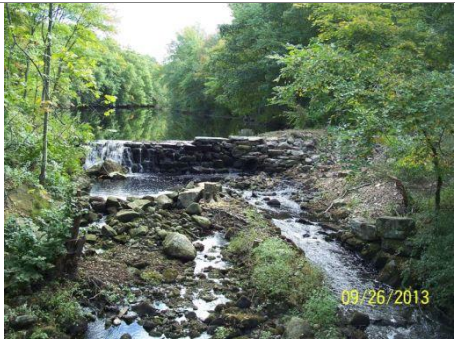
Dam Name	Dam ID	Town	River/Stream	Recommendation	Description	Photograph
Spaulding Pond Dam	10208	North Stonington	Wyassup Brook	Remove	The impoundment supports recreational uses. Repairs were recommended in 2013 (last documentation of correspondence in CTDEEP file). Once the dams on the Ashaway River are removed, removal of this dam would become a higher priority.

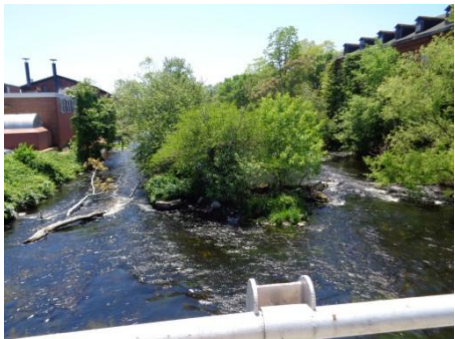
Stillmanville Dam	256	Westerly / CT	Pawcatuck River	Remove	This concrete structure does not prevent fish passage or have a significant impact on the flow regime. However, removal could provide other river restoration benefits.

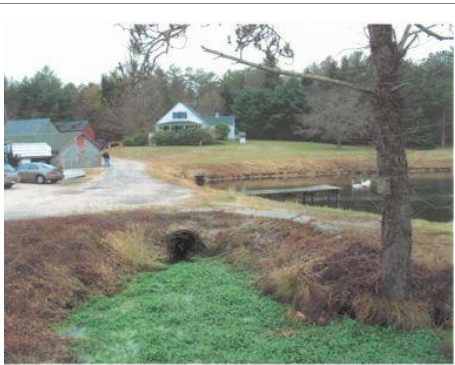
White's Pond Dam	261	Richmond	White Brook	Maintain	This impoundment is part of the RIDEM-owned Carolina Trout Hatchery, which is still in operation. RIDEM has been maintaining the dam.

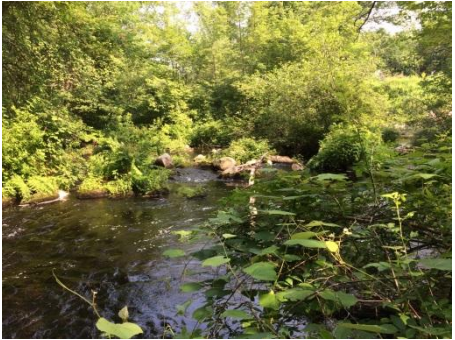
Wyoming Pond Lower Dam	217	Hopkinton	Wood River	No Action	The remaining structure is not preventing fish passage, is not significantly impacting the flow regime, and is only on one of several braided stream channels. The dam does not pose significant flood risk.
